## **How could it possibly get worse? Read on!**

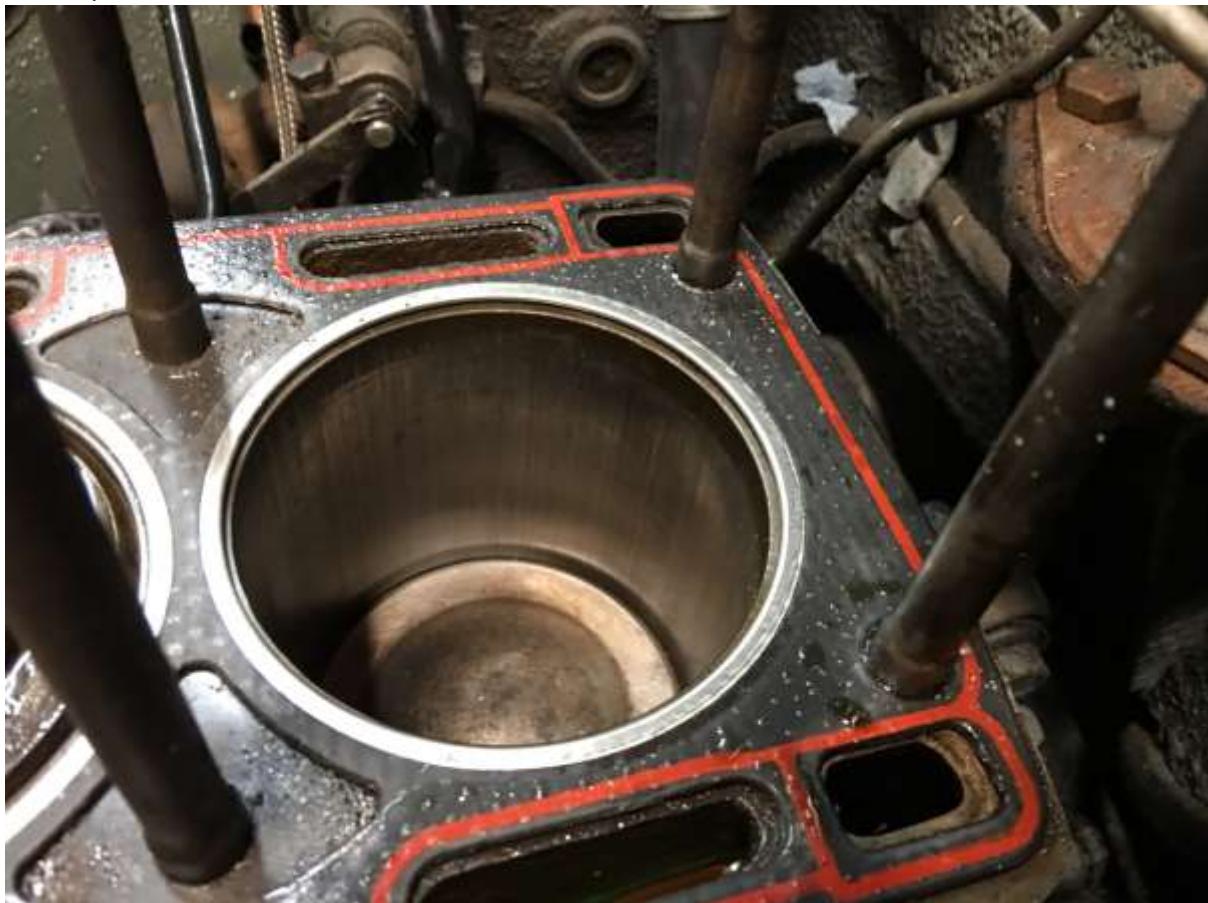
We left the Jag story at the point where the cylinder head had been removed for the second time to try to discover why the engine had lost all compression. The chief suspect was the new composite head gasket but on close examination there was nothing to suggest compression or water leaks on what were still, at this stage, cleaned faces. However, a quick glance at the cylinder bores made it all too clear why there was next to no compression. The bores were horribly scored. All six of them.

The picture shows the scoring but not really how deep those scratches are. So, how did it happen and what to do about it? One decision came quickly, I wasn't going to sell the car "As Is" and cut my losses. Far too daft for that but it was either a complete engine rebuild or a second hand engine replacement.

Replacement engine prices weren't encouraging. Anything with any sort of provenance was in the order of £5,000 and that is without a reliable guarantee. The other frightener is that, whatever the cost, the engine could have been built by someone like me! While the research went on I gave a lot of thought to how such damage occurred in the first place. It was obvious that some abrasive contaminant had got into the cylinders and that must have happened when the engine had been turning over whilst testing for oil pressure and water system leaks. This was all done with plugs out and turning on the starter. I suspect the contaminant got down to the rings and made a very successful job of ploughing up the bores. It may well turn out that the rings are damaged too. The block had been scrupulously clean prior to fitting the head and the head had been returned, "ready to fit". Well not quite as it turned out. In a conversation with the engineers they explained that after the machining work the head goes through a series of

machine washes and a chemical bath prior to assembly but they always recommend that the head bolt holes and waterways are cleaned by hand before fitting. Pity nobody thought to pass on that recommendation to me! In retrospect I should have thought of it for myself and it highlights the difference in the depth of knowledge between professionals and amateurs.

It took a few days to mull over the, "What next?" question before an intriguing option emerged that rekindled the sputtering flame of enthusiasm. I still had the cylinder block from a 1968 Jaguar 420 sitting in my cellar. Why not use the 420 block with the refurbished 3.4 cylinder head I'd spent so much time on? Hmm.....4.2 litre Mk2. Two hundred and twenty brake horse power. Hmm.....rather more poke than the famous 3.8 Mk2. Ah ha! Plan B in all its glory.

On examination very little was needed to bring the block to perfect condition but the bores did need to be taken from twenty to thirty thou oversize. All of a sudden I was getting very enthusiastic indeed as expert Ken and the engineering manager came up with all sorts of suggestions to improve the motor beyond what was feasible in 1968. New light weight pistons would raise the compression to 8.7:1 and the total capacity to 4.3 litres which set the scene for what should be quite a powerful engine and one with a considerable torque hike over the standard offering. These changes didn't add much to the overall cost and as this was always going to be a hybrid engine it seemed sensible to get the best out of modern technology where the real benefit to me would be reliability. The beauty of this approach was that I still had the original engine so if the car eventually became the property of a collector, it could still be returned to original.

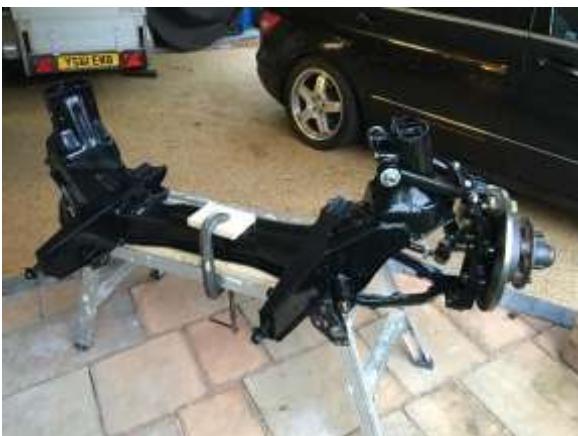
before you started? Well this was one of those occasions. For ease of access when rebuilding the subframe I set it up on a builder's step which was on a raised plinth just outside the garage door. Very particular care went into siting the step and mounting the subframe to it as you can see in the photograph. Plenty of access all round especially for fitting the long fulcrum bars would make the build-up a real pleasure. The build went well and after a few hours spread over three days we had a completed subframe. Such

a pity then that I hadn't thought about how it was going to get off the builder's step and back under the car. Still at least it looked great.

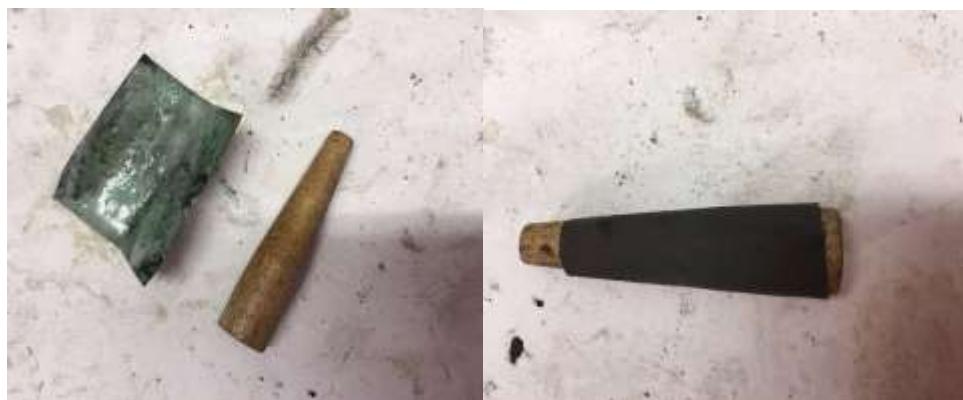
During the subframe removal from the car at the outset of all this work, we noticed that when the steering wheel was turned the lower end of the steering shaft moved a good half inch in whichever direction was the path of least resistance. This is a typical symptom of failed bushes in the steering column and quite common on this era of Jaguar. The final fix for the steering then was to remove, dismantle and refurbish the steering column. As expected the lower column bush had disintegrated completely and the upper bush was so worn that you could move the steering wheel laterally from left to right. This is the sort of job I like as it can be done sitting at the bench, in comfort with good light and a vice. Cleaned, painted and with new nylon bushes fitted, it looked great but..... I could barely turn the inner shaft. Why is it that every job seemed to need doing at least twice and sometimes three times over before it came right? I tried everything, lubrication, fitting the inner column into a drill to spin it in the bushes at 2000 rpm. Nothing relieved the drag which if left would mean no self-centring and unacceptably heavy power assisted steering.

Internet research suggested you have to be very careful in resizing nylon bushes. If the centre aperture is not perfectly round and correctly sized to the moving part, the wear rate is so high it will, in a very short time, become sloppy. Ideally the bushes should have been removed and resized with a reamer. Even more ideally the manufacturer should have sized them correctly in the first place. The final solution was to glue some 1,000 grade glass paper to a correctly sized

wooden dowel with a tapered lead in. The principle was to allow the glass paper on the lead in to resize the aperture of the bushes and then the

correctly sized dowel and glass paper to ensure the aperture remained properly rounded. Not a proper engineered solution but it worked in as much as the turning drag was gone whilst leaving no lateral play at all. Time will tell if it is going to wear excessively.
