Oh Dear!!

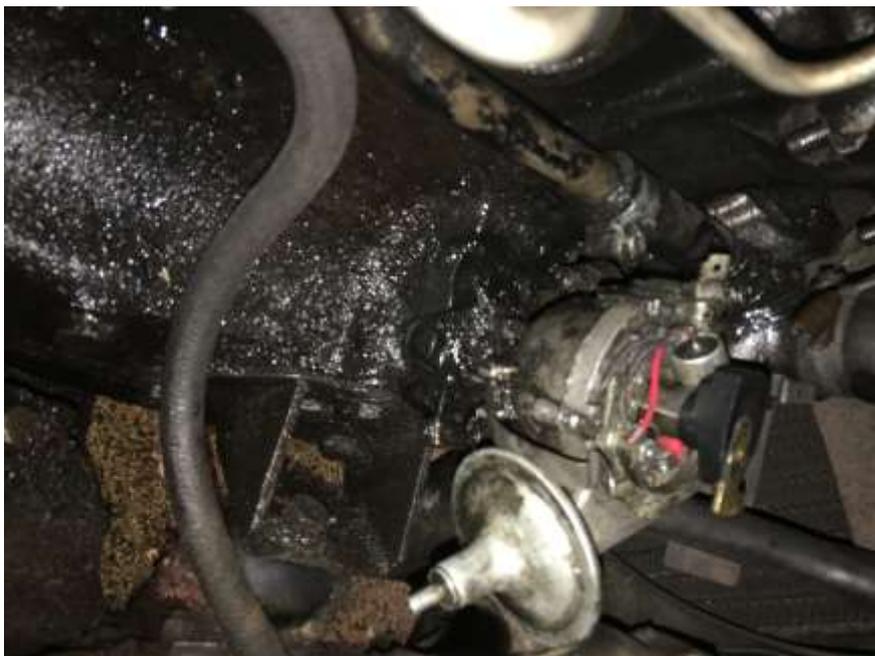
you actually want to work on. Trying to get round things in that engine bay is a bit like trying to peel a wet potato through a letterbox with sharp edges. So off came the bonnet, the air cleaner assembly, the battery and the carburettors. All of this takes about 30 minutes and the access and visibility gains reward that effort many times over. Now that I could see more, another

issue was revealed. The inlet side of the engine was caked in oil sludge. How?? There are no oil outlets apart from the filter and that was clean. Well a good source turned out to be someone leaving six of the bolts that secure the front of the cylinder head and its timing chain cover in a tin somewhere because they were not attached to my engine. Nor was the top of the chain housing. You have to wonder how mistakes like that happen. A full service history is all very well but it doesn't mean that inexpert hands, like mine I suppose, haven't also had a go.

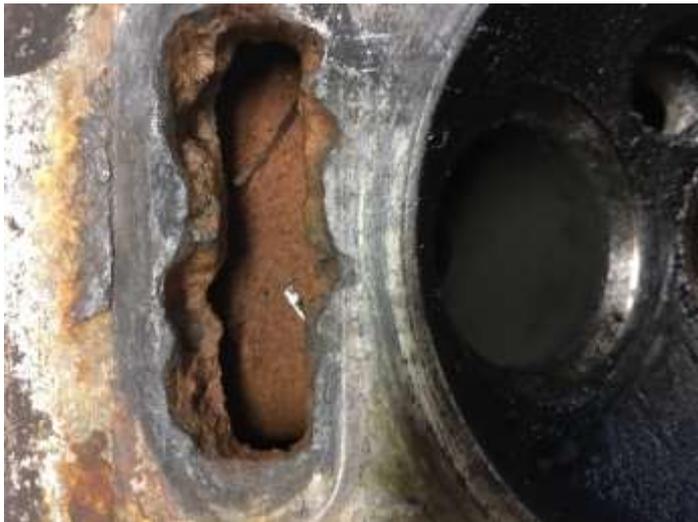
The upside of the missing bolts was that there was a bit less work to do to remove the head and forty five minutes later it was sitting on the bench but.....Oh Dear. This is going to be more than two day's work!

It took no expertise at all to realise this cylinder head was in a parlous state with badly corroded waterways, deeply recessed valves and no evidence of the inlet oil seals that are supposed to reduce oil consumption on the inlet valve guides. This really was a two cups of tea level of disappointment because it was going to be a highly intrusive engineering job to recover the head if indeed it could be recovered at all. With the head stripped it was apparent that it needed new valves, guides and seats plus rebuilding of the corroded

The cylinder head went to a recommended engineers in Bawtry with a package of spares including new valves, bronze self-lubricating guides, valve springs and followers all from the Jaguar V12 engine. This is where single make clubs do come in very handy. Their engine gurus can tell you not only what works and improves on the original specification but also where to acquire good quality spares. This is so important because there are many suppliers offering parts at attractive prices which when acquired prove to be of such hopeless quality that you daren't use them. Ask me how I know this! I was advised that the V12 valve gear is significantly stronger but lighter than the original XK components and that as a result of the upgrades the sustained upper rev limit is safe to 6,000 RPM rather than the standard 5,500 RPM. Actually I doubt that benefit will have the smallest impact on the way I use the car but it reads well and should contribute to reliability. The JEC run a very competitive race series for XK engined cars and that is where a lot of the knowledge on reliability and functional improvement comes from.

I had elected to have the head built up by the engineering company as for me this was a cheaper option than buying the large box of shims necessary to achieve the accurate valve clearance between cams and followers. As such it was a ready to fit item that I collected five weeks after removing it from the car. It had needed a lot of work, welding in new metal, recutting the waterways, new valve seats and guides plus all the kit I had supplied. It was also discovered that one of the bolt holes that secure the head to the block had been drilled out, presumably to fix a broken stud, compromising the strength and rigidity of that fixing point. To fix it the bolt hole had to be machined out fully and sleeved so that full strength would be returned when the block was bolted down with the required 60 lbs ft of torque.

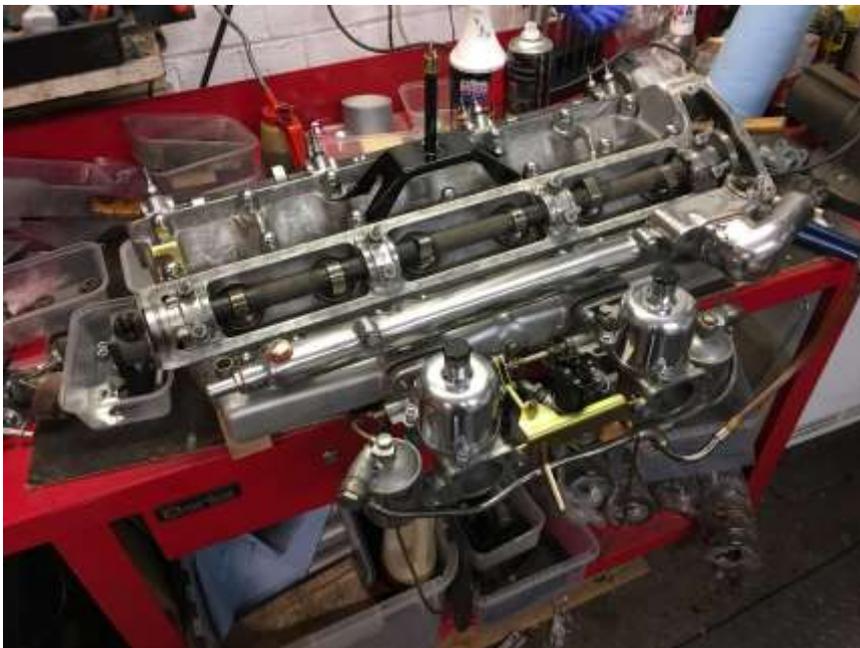
Whilst this was going on attention turned to the twin SU carburettors which were stripped and rebuilt using new SU internals from Burlen Services. With a bit of time taken to re-polish all the alloy components that were originally polished from the factory it all looked pretty good. This was a real labour of love because they were quite corroded after fifty five years and even my favourite Autosol wasn't going to bring it back properly. With a kit of polishing buffs you fit in a drill (MachineMart) the alloy came back to something like it should have been but it took hours and is a pretty filthy job. Should you care to take this on I suggest a full face mask as even with safety glasses and a mask it still looked like I'd been using eye-liner and I'm too old for that look now.

Before fitting the cylinder head on an XK it is a good idea to fit the inlet manifold. It has a series of bolts underneath the manifold housing that are very difficult to reach once the head is in the car so doing it now is a time saver. It is also worth taking the time to fit the carbs to the manifold whilst it is on the bench. This makes the initial set up easier as you can see things such as the jets height to the bridge and
