## Making Good At Last

In case you are new to these articles the story has reached the point where an unexpected engine rebuild on a 1964 Mk2 Jaguar has at last reached the point where something could be built rather than dismantled.

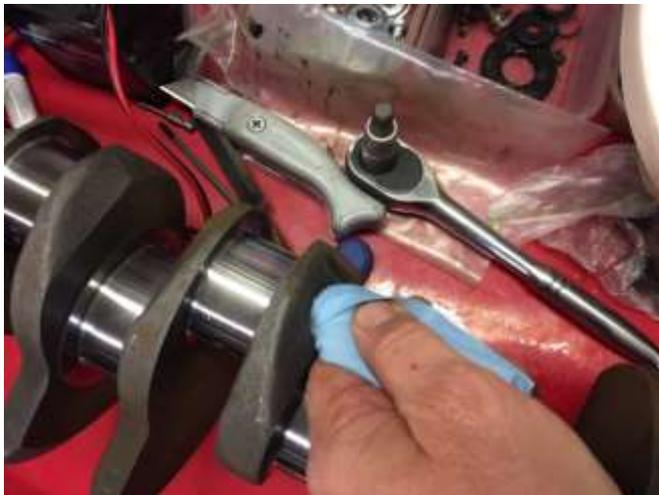
Readers of these articles may remember that the original engine suffered major damage as a result of contamination that entered the bores probably from the rebuilt cylinder head. After that fairly hard lesson this build was going to be meticulous in its attention to cleanliness. The first job then was to get the re-polished crankshaft on the bench and thoroughly clean the oil ways. Having been

acid dipped and pressure washed you could reasonably expect that nothing much would be needed but this wasn't the case. The Jaguar crankshaft like most others has a series of sludge traps in the big-ends and using small brass wire brushes and nylon bottle brushes these were thoroughly cleaned with brake cleaner. A surprising amount of muck came out of these oil ways underpinning the need to carry out your own cleaning even if your remanufactured components are listed as "ready to build".

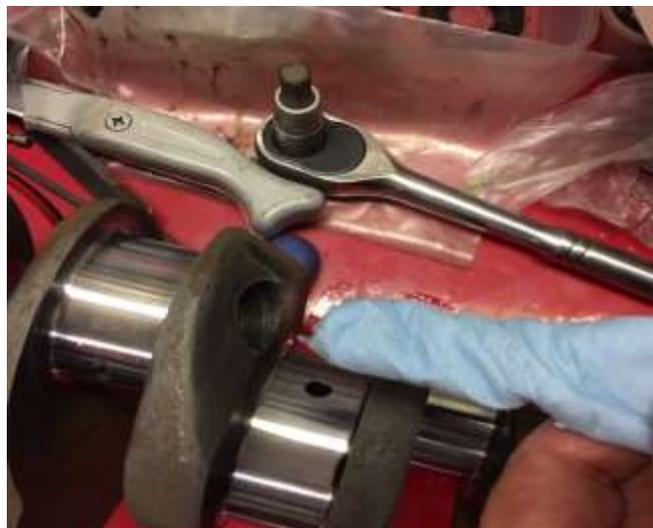
Apparently oilways absorb the oil contaminants into the metal of the sludge traps over time which is why it takes strong solvents to deep clean them. I was also told that this is why rebuilt engines still cause new engine oil to discolour quickly after an oil change where this doesn't tend to happen with a brand new engine. This cleaning effort took several hours spread over three days because leaving the chemicals to soak the metal gave better results than just wiping out. It also seemed to be that Carburettor cleaner was more effective at removing the old oil residues. The only way to know if you are succeeding is to keep going at it until the paper towel or cloth comes out clean which eventually it does. You will probably also have alabaster white hands with not much in the way of nails as the various chemicals erode skin and keratin. I just told people it was a result of having been tortured which makes for good dinner table conversation! At the NEC Classic Car show a few years ago I saw what professional engine rebuilders and racing teams now use to clean components and assemblies. It is the equivalent of a giant dishwasher that works at high pressure and very high temperatures to achieve almost

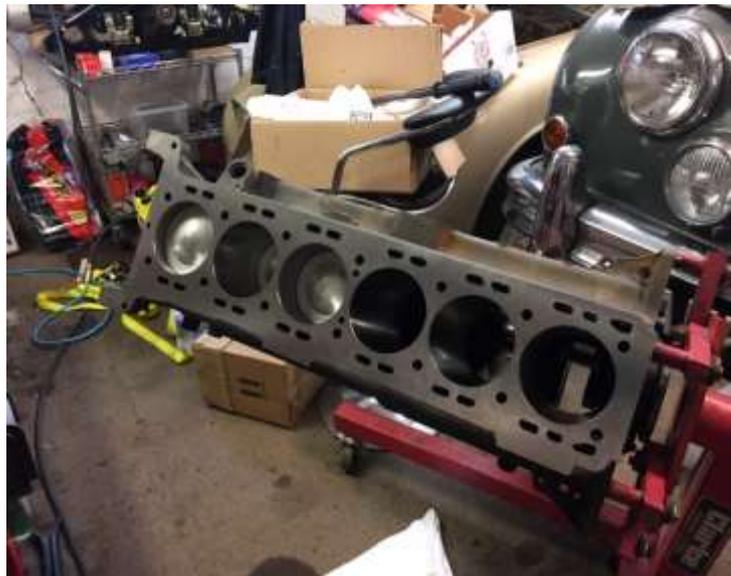
At this point the engine is spun over on the engine stand to turn it right side up. For reasons I've never understood these engine stands all seem to be supplied with a turning lever the length of a piece of spaghetti. I think it was Archimedes that said, Give me a place to stand and a lever long enough and I will move the world. Well readers who have stayed with me this far will know, I can take a hint! A meter long chrome steel tube (that once was a table leg) meant that I really could now rotate a Jag engine on my cheapo engine stand.

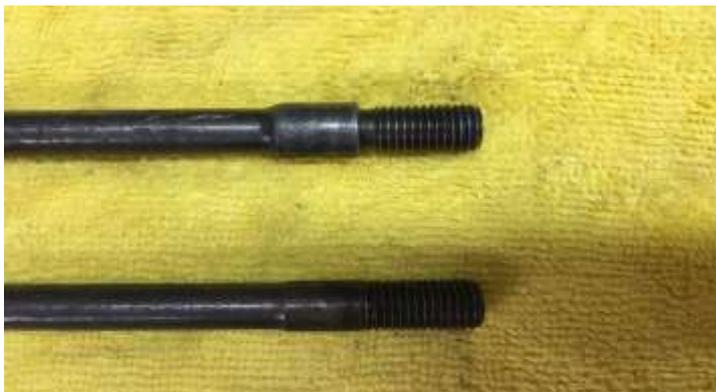
We looked, we examined, we measured, poked and prodded. We ran a spare stud through every stud hole on the cylinder head with no resistance at all. Eventually, the Eureka moment. That stud

looks a bit fat at the top!! And it was. When we put the Vernier on the stud it had a collar radius that was twenty eight thou greater than all the other studs. It seems obvious from the picture but without a standard stud next to it for comparison you really wouldn't see the difference. I have no idea where it came from or what it was intended for but replacement with the spare stud solved the

problem and the head dropped on perfectly.

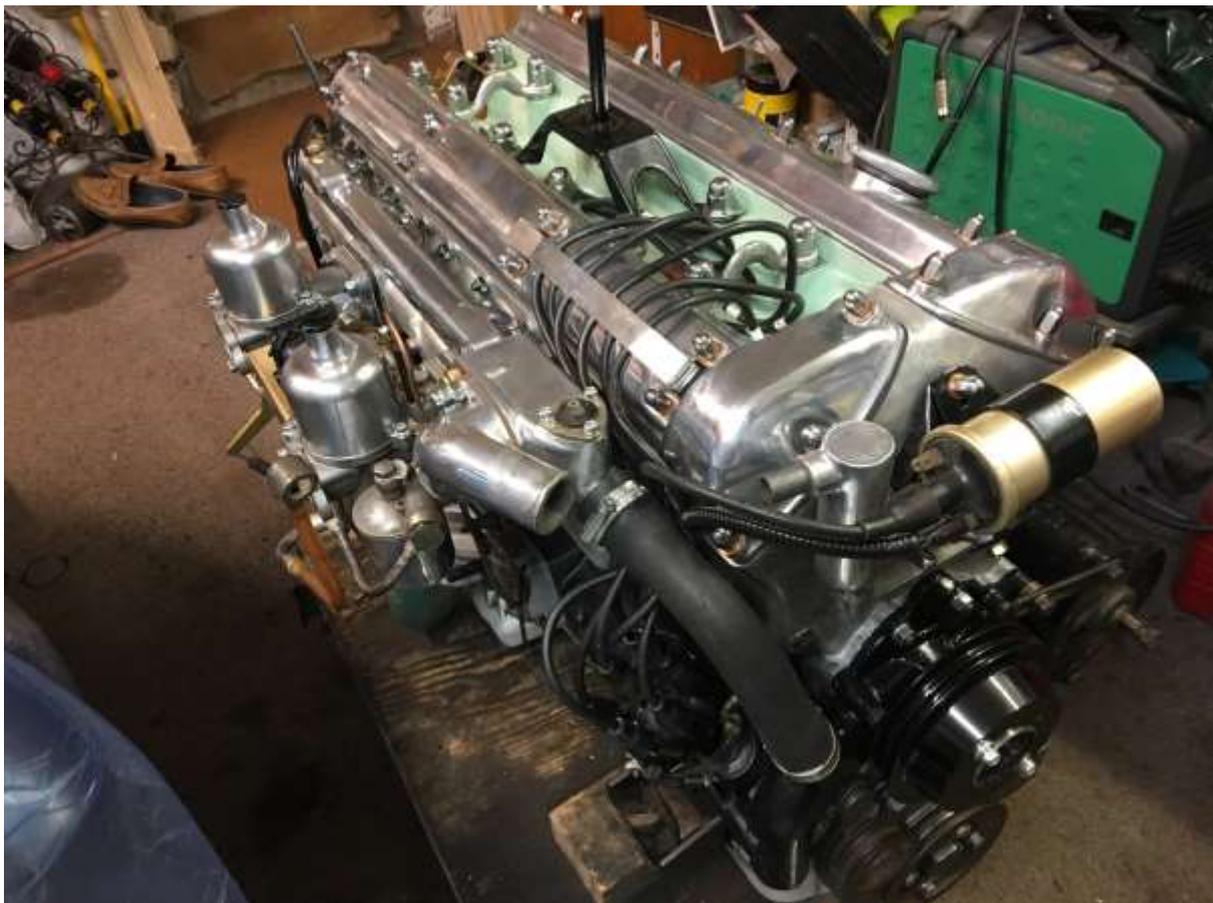
The new XJ6 spec leads were added and configured to the standard firing order and plugs fitted to keep the bores free of contaminants. I gave all the bores a good squirt of WD40 too just in case any damp got in.
